Case: Checking of the pin on the brake lever

This preventive pin locking control concerns the main brake cylinders for the central tunnel, that are the following catalog numbers:

K-446A-000, K-412B-000, K-426B-000, K-438B-000

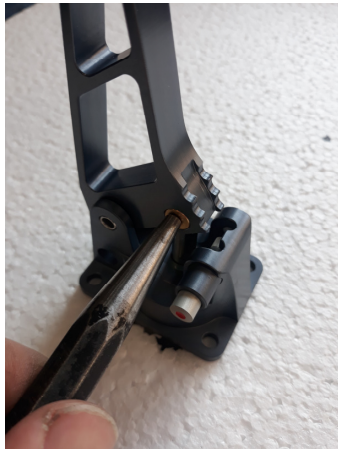
In one case, the pin was slightly extended from the lever. When moving the lever, the pin touching on the cylinder holder. As a result, it was not possible to create sufficient pressure on the piston and the brake became ineffective.

Check pin fastening:

Use a smaller pin, push from the side on the pin, force 2-3kg. They should not move, then no action is required. This check can also be made with pre-flight check and routine technical inspections.

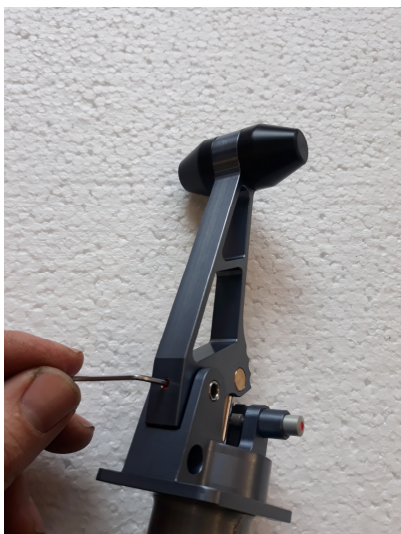
Remove the red colour in front of lever and loose the M3 stud bolt

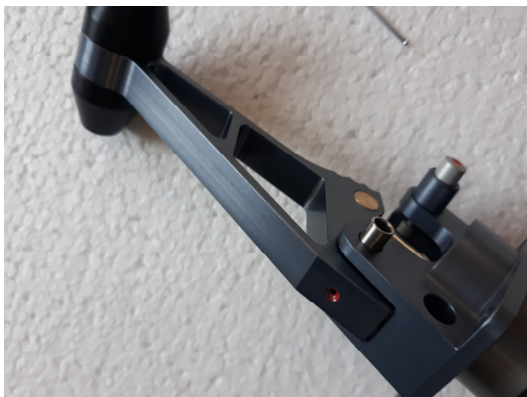
Press the lever pin out and remove the lever. Beware of side spacers, do not lose them.

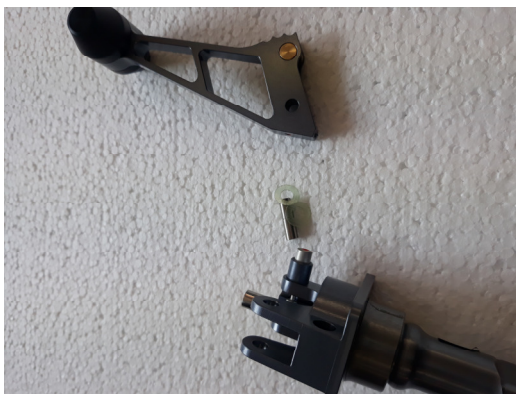
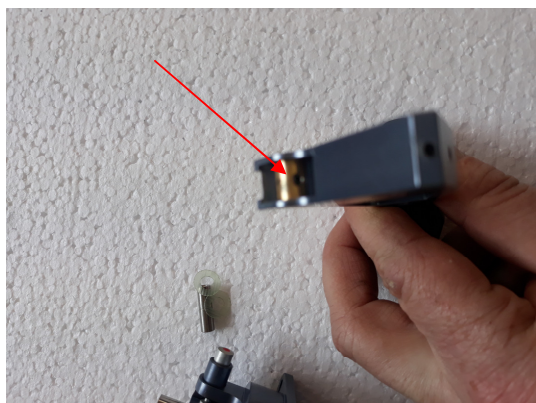
This bolt on the pin is the securing bolt (M3). Fully unscrew the bolt, apply Loctite 603 (or other, similar, for securing of cylindrical parts) in to the thread hole on pin, insert again the M3 bolt, tighten them in the position as shown.

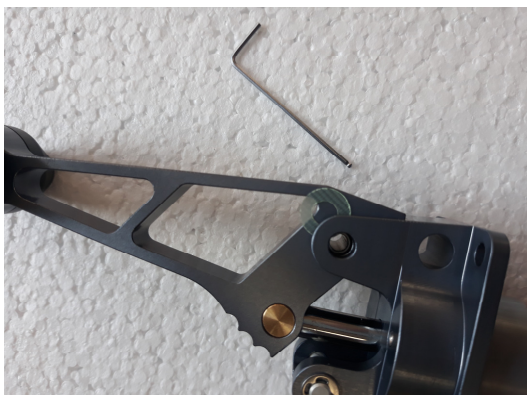
Reinstall the lever, spacer washer, pin.

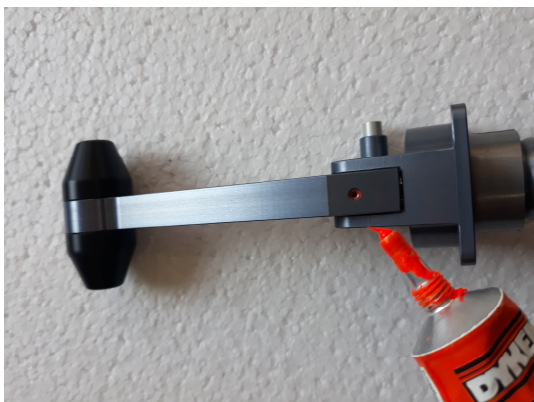
Tighten the bolt of lever pin, dip it with paint
